**RE: TRANSMITTAL –INTERIM REMEDIAL MEASURE COMPLETION REPORT
UPPER SLUICeway
GENERAL CHEMICAL CORPORATION / HONEYWELL INTERNATIONAL INC.
DELAWARE VALLEY WORKS FACILITY - CLAYMONT, DELAWARE
DOCKET NO. RCRA-3-089CA**

Interim Remedial Measure Completion Report Upper Sluiceway

Delaware Valley Works Facility
6300 Philadelphia Pike
Claymont, Delaware

Docket No. RCRA-3-089CA

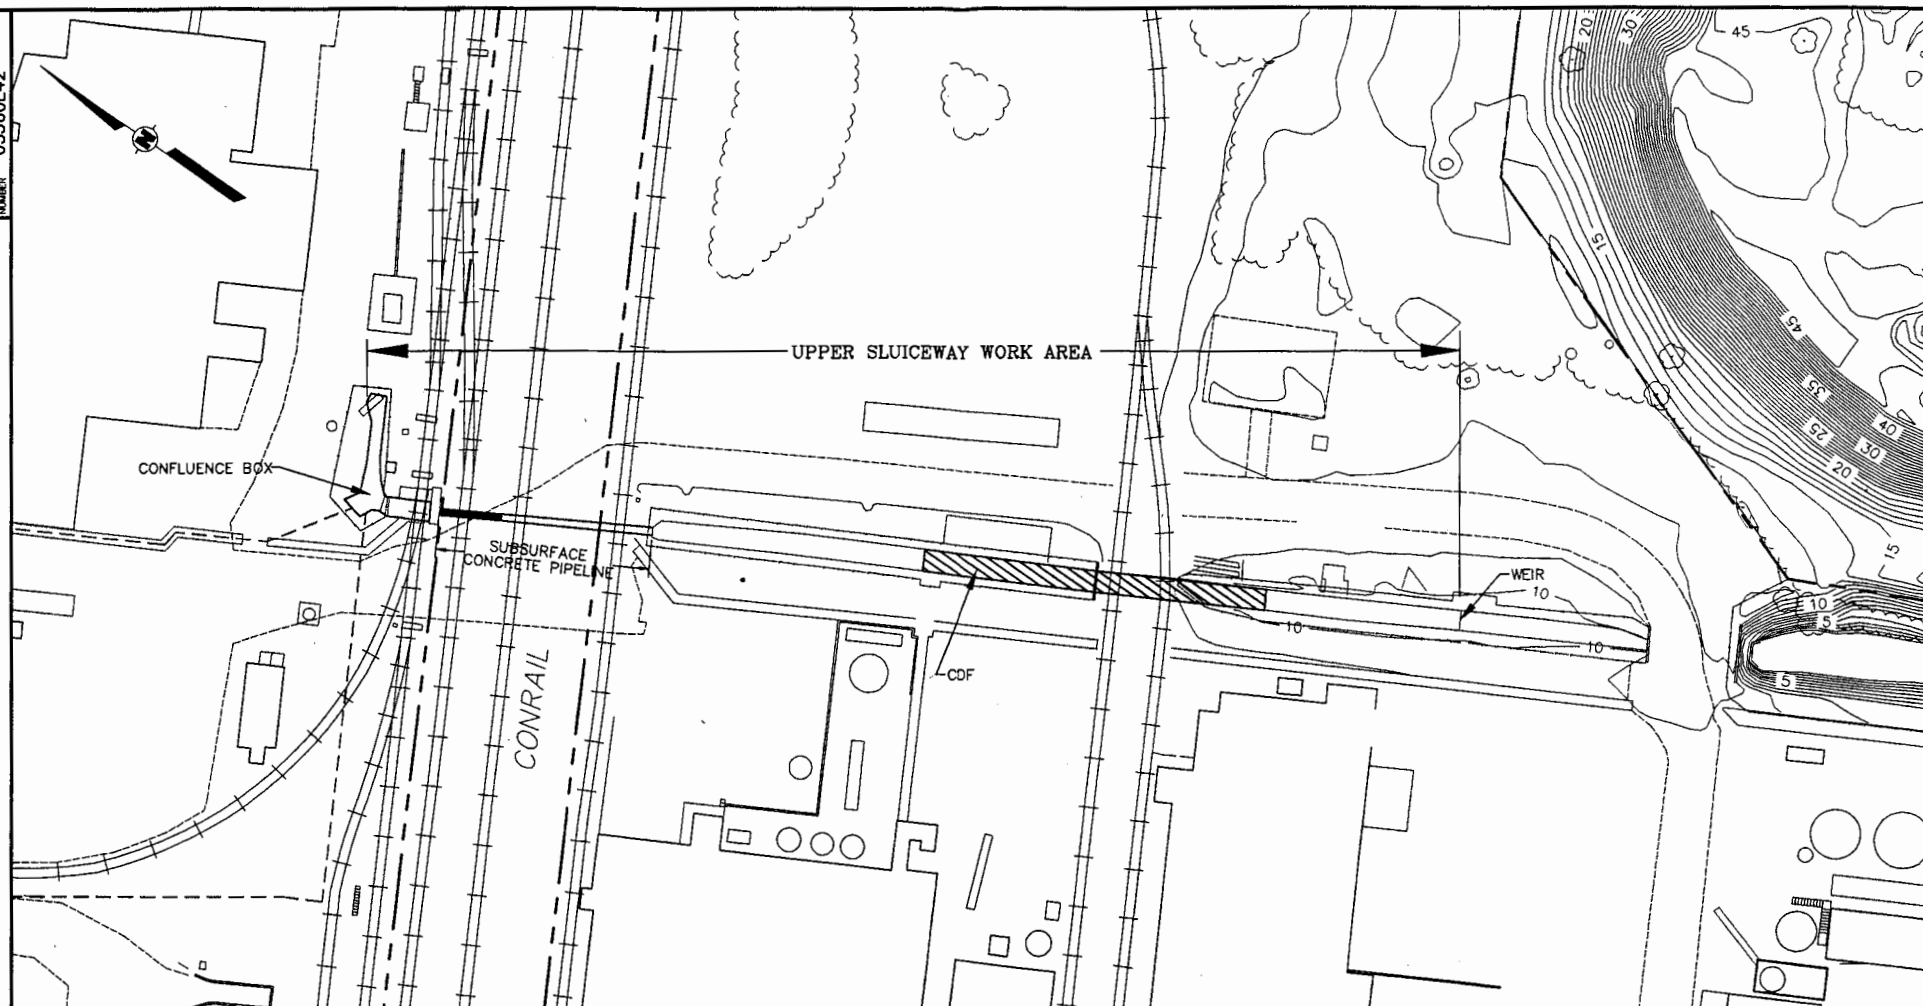
Subsurface Concrete Pipeline Cleanout and Video Inspection: Water jetting was used to clean the subsurface concrete pipeline, and a vacuum truck was used to remove the sediment as it accumulated at the end of the concrete pipeline. Upon completion of the cleaning effort, a video inspection was completed using an unmanned track crawler which entered the downstream end of the pipe and inspected the pipe in an upstream direction. The video inspection revealed a partially collapsed area in the pipe approximately 25 feet in length, approximately 74 feet from the opening at the downstream end (Figure 2). Material remained in the subsurface concrete pipeline beginning at approximately 66.5 feet from the downstream opening and increased in quantity approaching the collapse. The material appeared to consist mostly of gravel and appeared to be substantially free of soft sediment. The video inspection was terminated at the location of the collapse due to the obstruction created by the material remaining in the pipe.

According to the Site maintenance manager, the area above the collapsed pipeline has previously been filled with railroad ballasts as part of periodic railway maintenance operations in order to maintain track elevation. It appeared from inspection at either end that the collapsed concrete pipe and a portion of the additional placed ballast have filled the collapsed pipeline. Although this material has created a physical blockage, sufficient voids remain to allow water to flow through the collapsed section of pipe.

The video inspection was abandoned at the location of the collapse due to the obstruction created by the material remaining in the pipe. The video showed that the concrete pipe was cleared of visible debris and sediment, to the best extent practical. Based on the current conditions of the collapsed pipe, full clearance of debris and sediment from within the storm water conveyance would require reconstruction of an underground culvert below the rail tracks and interruption of rail operations which is beyond the scope of this interim remedial measure. The IRM Work Plan

Previously unknown conditions were encountered during the removal of soft sediment from a section of the sluiceway near the lower road crossing where concrete abutments support a bridge crossing. When soft sediment removal was attempted in this section, wooden cross-members were encountered that extended across the sluiceway at the base of the concrete abutments beneath the sediment. The wooden cross-members provided structural stability, and it was determined that they must remain in place. Steel cross-members were installed upon the completion of soft sediment removal and cover system installation in order to maintain the structural integrity of the concrete abutments. In addition, the extent of soft sediment in this area exceeded what had been anticipated, and competent material for the cover system was not encountered.

Dewatering Activity: Mobile Dredging isolated the storm water system by plugging the active storm water lines immediately upstream of the confluence box and diverting the storm water flow by pumping it (after treatment) to a point in the sluiceway downstream of the weir and the active work area (Figure 2). This work was initiated on December 3, 2012. Prior to discharge back into the sluiceway, the storm water was pumped through a set of 50 and 5 micron filter units and into frac tanks staged next to the storm water treatment building. The diverted flow was then pumped to the storm water treatment building where it was treated, as needed, to achieve compliance with the facility's National Pollutant Discharge Elimination System permit. The treated storm water was then discharged back into the sluiceway. The dewatering effort also included pumping water from the confluence box and sluiceway on an as-needed basis where water entered the active work areas. Dewatering activities were required on an ongoing basis during remedial activities.

Soft Sediment Removal Activity: Soft sediment removal activities (Figure 2) were completed by using a combination of heavy equipment (i.e., excavator and skid-steer loader) and manual techniques (vacuum, water jetting, and hand scraping). After selected crossbeam supports were removed from the sheetpiled portion of the sluiceway and the sluiceway was sufficiently dewatered, the excavator was used to expose competent material just below the downstream end of the subsurface concrete pipeline and the skid-steer was placed in the sluiceway. Thereafter, soft sediment was relocated using the skid-steer to a location in the sluiceway where the excavator could remove the sediment from the sluiceway and place it in rolloff containers. The soft sediment was stabilized/solidified by the addition of a super absorbent polymer (SAP), ZapZorb® prior to removal from the sluiceway.

The soft sediment removal methodology was adjusted to address these new conditions and additional structural bracing was installed throughout this section due to safety considerations. A vacuum truck was used to "over-excavate" the soft sediment. A controlled density fill (CDF) was then placed by pumping in the "over-excavated" areas and, as described in the IRM Work Plan Addendum No. 1, around the wooden cross-members (Figure 2). The CDF was placed to the top of the existing wooden cross-members in order to provide a suitable, stable base for the AquaBlok® cover system. The use of CDF was a modification to the IRM Work Plan and is described in the IRM Work Plan Addendum No. 1.
